# CALIFORNIA INSTITUTE OF TECHNOLOGY

## **THE VERACRUZ EARTHQUAKE OF 28 AUGUST 1973**

by  
H. Max Irvine

EERL 73-06

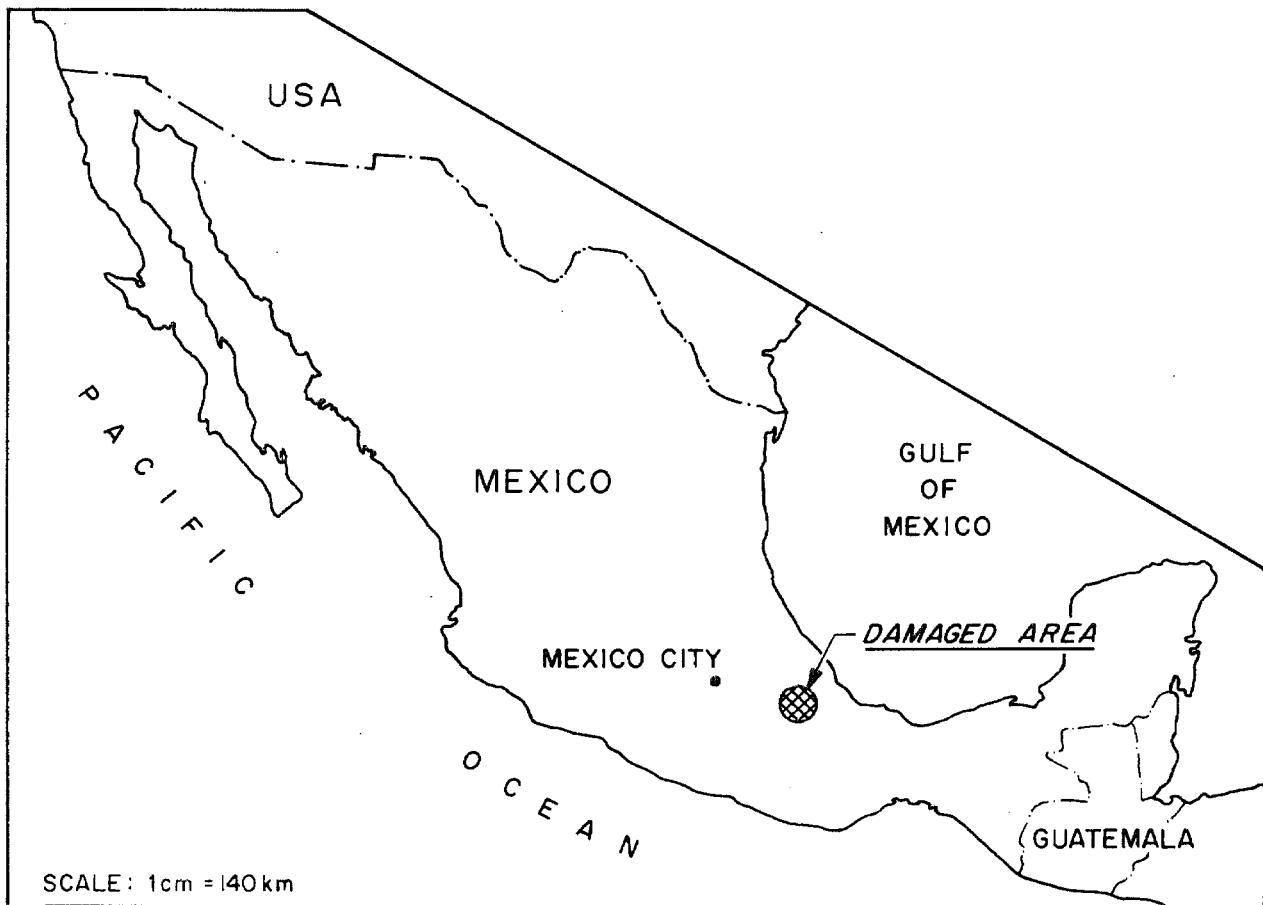
Figure 1 Location of damaged area.

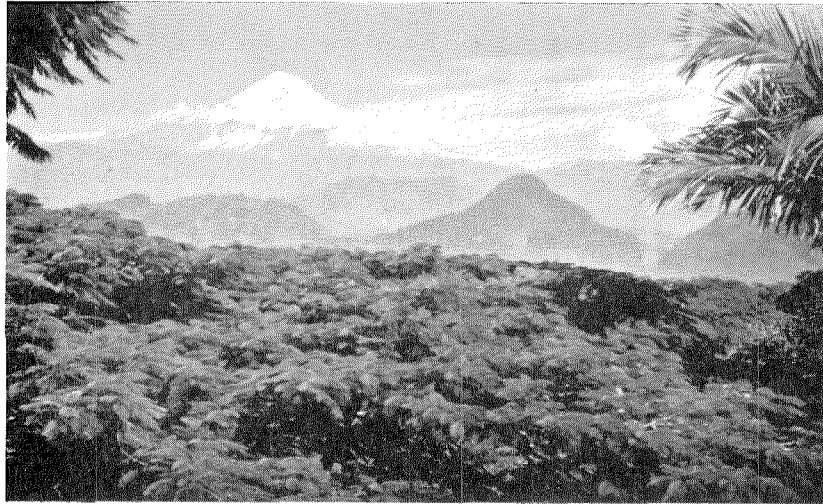
Figure 2 Typical view of the countryside in the damaged area of the state of Veracruz. Orizaba Peak (5,700m.) is in the background.

The damaged area in the State of Veracruz is in a tropical, mountainous region. Dense rainforest covers the slopes; coffee and sugar cane are farmed extensively. Figure 2 shows a typical view of the countryside, with the highest mountain in Mexico, Orizaba Peak (5,700m.), in the background. The earthquake occurred during the rainy season, and this naturally hampered rescue work. Serdán, in the State of Puebla, has a much dryer climate, as it is in the rainshadow on the other side of the mountains. The main crop there is corn.

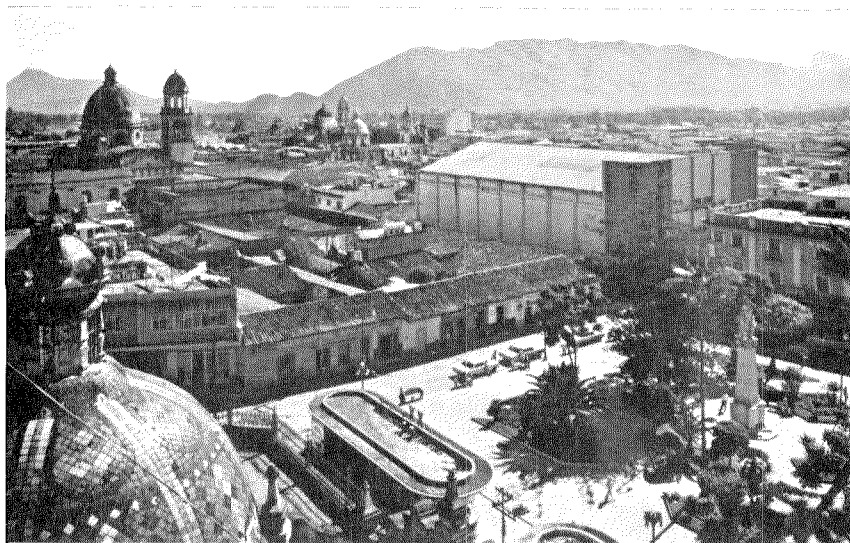
Figure 7 View of Orizaba taken before the earthquake.

There was quite extensive damage to a variety of buildings in Orizaba (110,000 pop.). Many houses collapsed but, since these failures were, in general, similar to those mentioned earlier, they will be passed over in order to concentrate on descriptions of larger, more modern buildings which often fared badly in the earthquake. Figure 7 (p. 3 ) shows a general view of Orizaba taken before the earthquake.

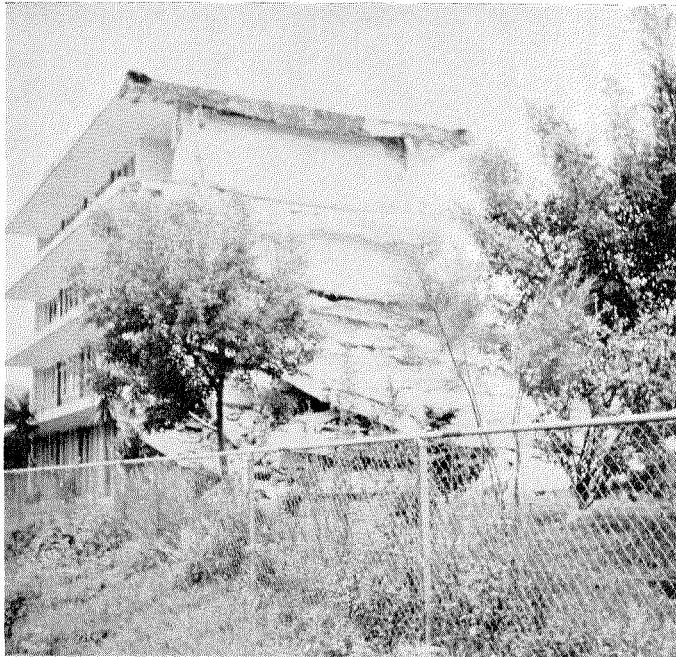
C. Technologico of Orizaba. — This modern complex of school buildings is situated on the outskirts of Orizaba and provides tertiary technical education and training for the area. Two four-story classroom blocks had been extensively damaged. The buildings had reinforced concrete frames and floor slabs, and brick filler walls. Other single-story buildings on the site had suffered little damage. The first four-story building (Building A) shown here consisted of two parts linked by stairways. Half of the structure collapsed completely (see Figures 16, 17, 18, pp.23, 24). Along the shorter sides adequate stiffness had been provided by four brick and mortar shear walls, but the building was weak along its major direction. Indeed, the rectangular columns were oriented so that their weak direction was parallel

Figure 17 Building A, Technologico of Orizaba.

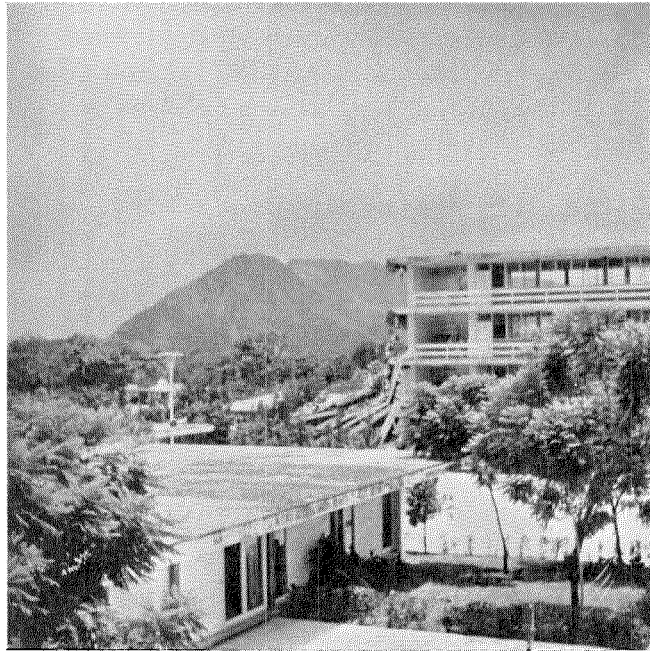
Figure 18 Building A, Tecnologico de Orizaba.

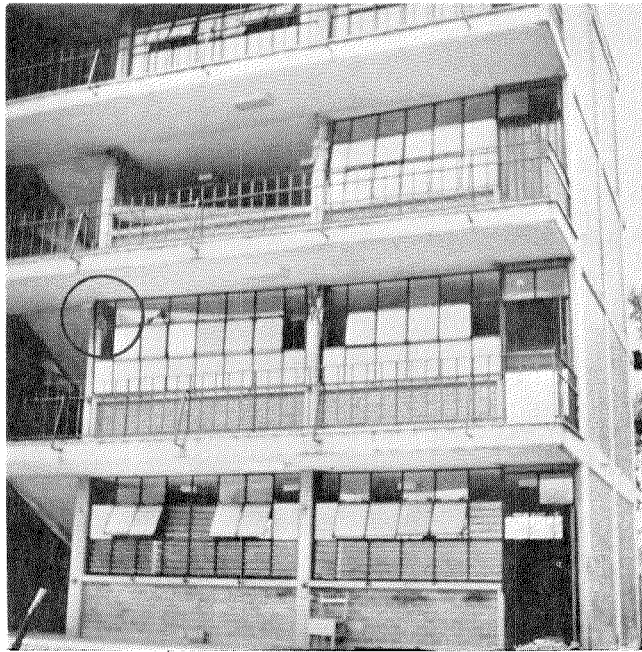
The other four-story building (Building B) remained standing, although it is likely that it will have to be completely rebuilt (see Figure 21, p. 25). Superficially, this building appeared to be similar to Building A; it was of the same height and plan area and stairways separated the building into two parts. However, closer examination revealed major structural differences. The center of mass of the building was towards the left-hand end, while the center of stiffness was nearer the stairway (see Figures 21 and 22, pp.25,26). Hence, the building responded primarily in torsion. Good evidence of this is provided by Figure 23 (p. 26 ) which shows classical torsional cracking of a second-story column located adjacent to the stairway.

Figure 22 Building B, Technologico of Orizaba  
(circle gives location of Figure 23).

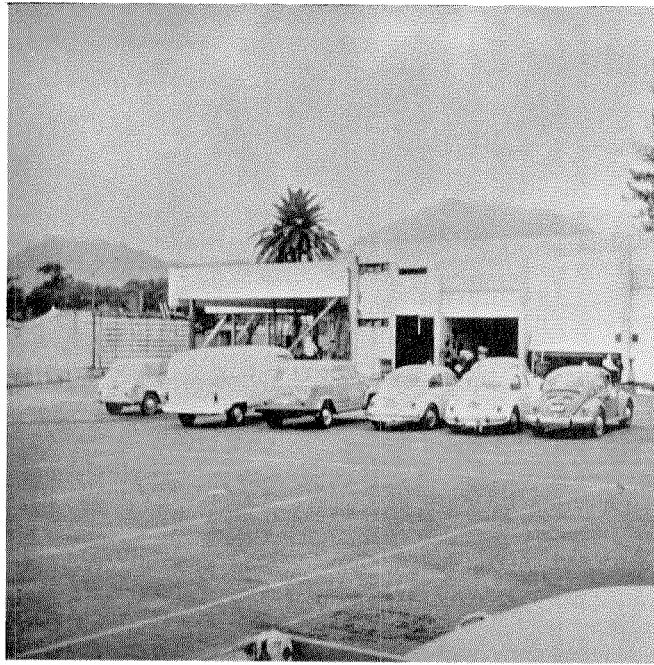
D. VW Garage Showroom. — This building, which was still under construction at the time of the earthquake, consisted of workshops and a service area of brick and mortar with a plate glass showroom facing the highway (see Figure 24, p.27). The single-story showroom consisted of several bays of tapered, post-tensioned, concrete I-beams supporting a continuous reinforced concrete roof slab, and supported by steel RHS columns at each end. Effectively, the roof beams were simply supported over a span of approximately 15 m. (see Figure 25, p. 27 ). Extensive vertical tension cracks at the mid-span

Figure 24 VW Garage Showroom, Orizaba.

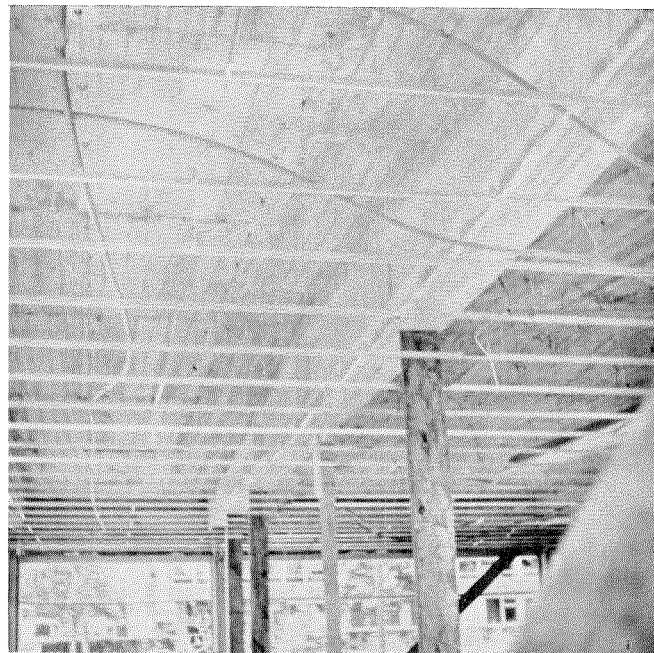
Figure 25 View of prestressed roof beam and roof slab, VW Garage Showroom, Orizaba.

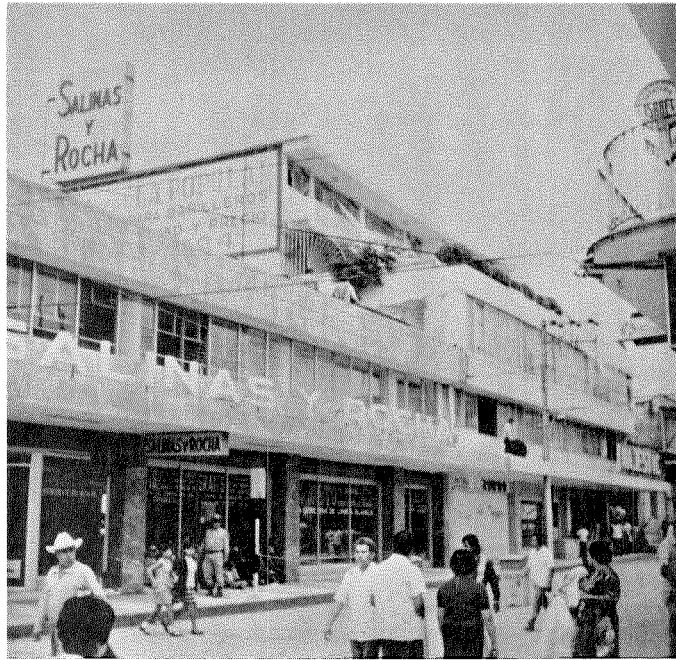
A. Five-Story Business House. — The failure of this building was one of the most interesting, from an engineering standpoint. This building, which had a reinforced concrete frame with brick filler walls, is owned by Mr. Kushida, a Japanese businessman, and was built in 1968. The bottom three floors house shops, offices and warehouses, whereas the top two floors, which are set back (see Figure 30, p. 30 ), are occupied by Mr. Kushida and his family. The overturning moment resulting from the motion of the top two floors caused axial compression failures of columns on the third floor (see Figure 31, p. 30 ). The upper floors had dropped approximately 30 cm. Damage to the

Figure 30 Five-story business house, Córdoba.

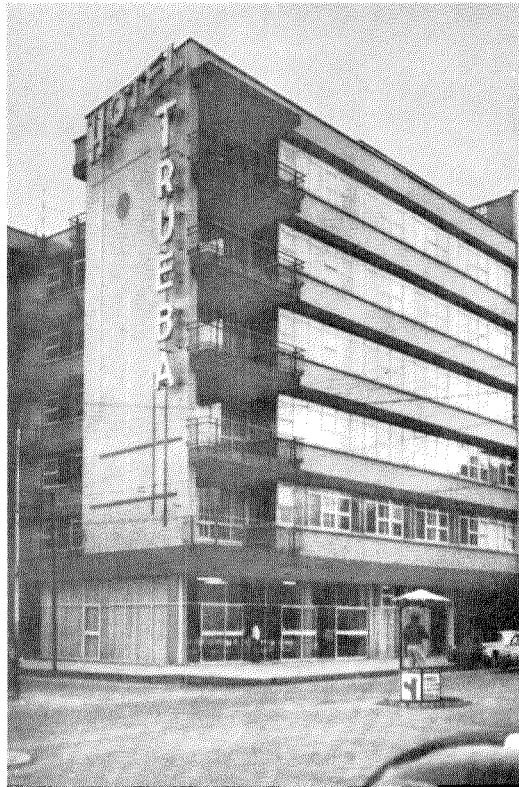
For whatever reason, the behavior of the wall is peculiar since Figure 34 (p.32) shows an obvious zone of weakness at the level of the ground floor columns. Yet inspection showed no sign of damage to these columns. It can only be concluded that sufficient stiffness was present in the ground floor to avoid damage there. Figure 36 (p.33) shows a typical interior beam-column joint. Since many of the rooms in the hotel were uninhabitable owing to broken partition walls, the owner was very keen to have repairs made as soon as possible. Unfortunately, the philosophy behind the repair scheme left much to be desired, as Figure 37, (p.33) shows.

Figure 34 Hotel Trueba, Córdoba,  
before the earthquake.

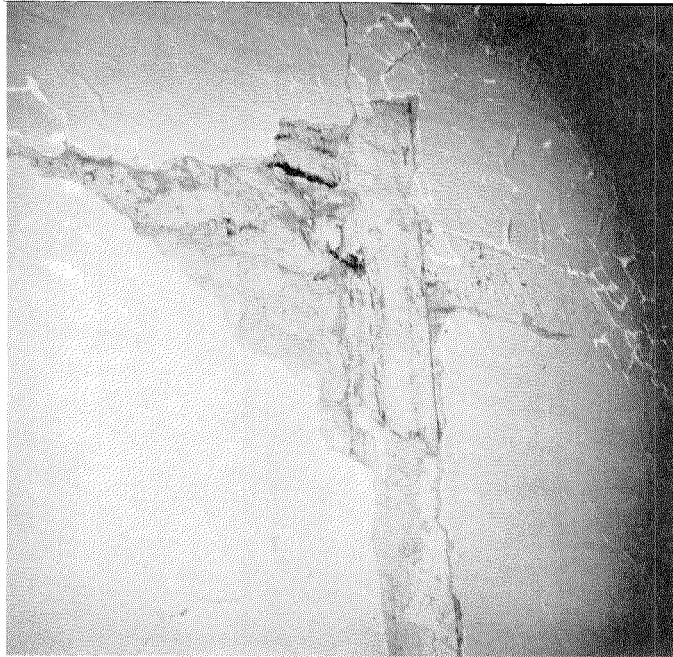
Figure 36 A typical interior beam-column joint, Hotel Trueba.

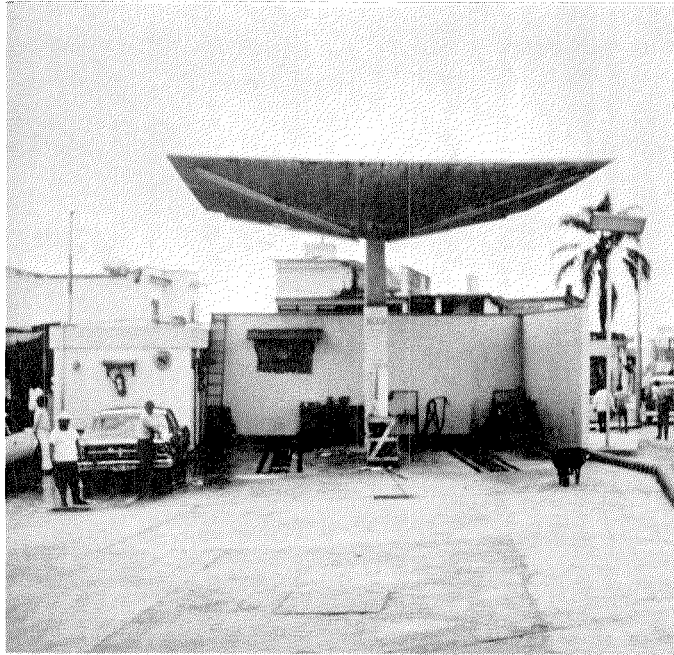
Figure 40 Service station shelter, Córdoba.

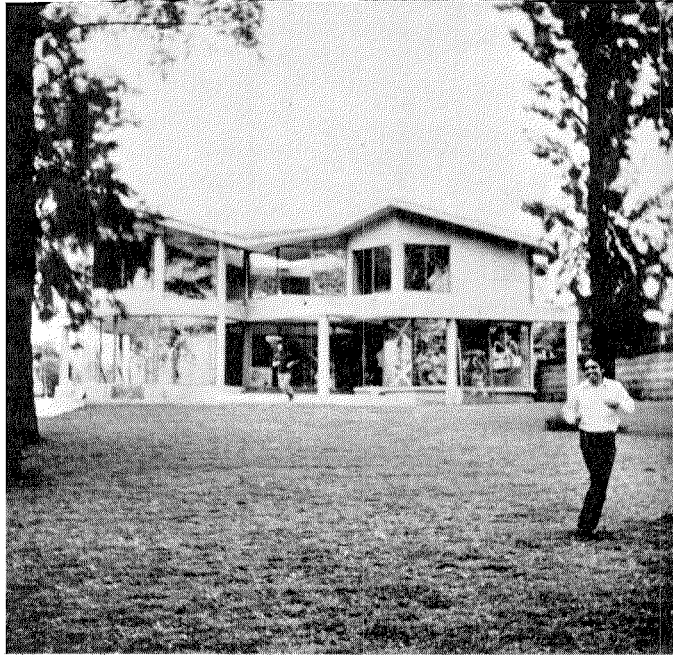
Figure 43 (p. 36) shows typical damage to one of the better constructed houses in Córdoba. The next three views (Figures 44, 45 and 46, pp. 37, 38)

Figure 44 View of a modern house under construction in Córdoba.
